Manhole Inspection Summary

Manhole # S47G__038MH

Insp Date: **5/1/08 11:21 AM**

Location Address: **204 S Chester St**

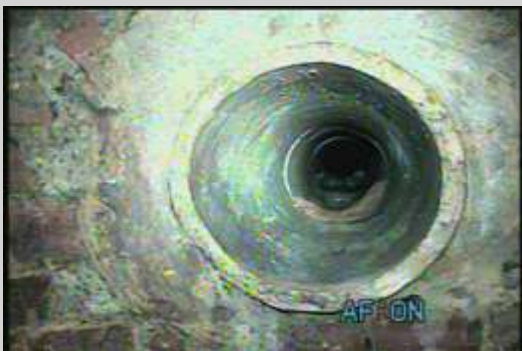
3 O'Clock Inflow

Pipe Material: **Clay** ☐ Pipe Lined

Invert Depth: **8.33** (ft.) Flow Characteristics: **Fast**

Deposits: ☒ **None** ☐ Mud ☐ Sludge ☐ Debris ☐ Grease

Infiltration: **None** Pipe Seal Cond: **Unknown**

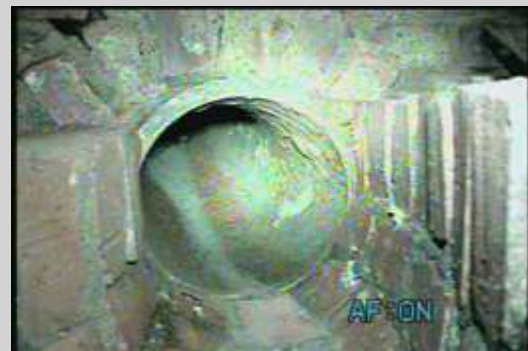
Drop In @ 3 O'Clock

Drop: **Outside Direct**

Inv Depth: **11.50** (ft.)

Drop Condition: **Open**

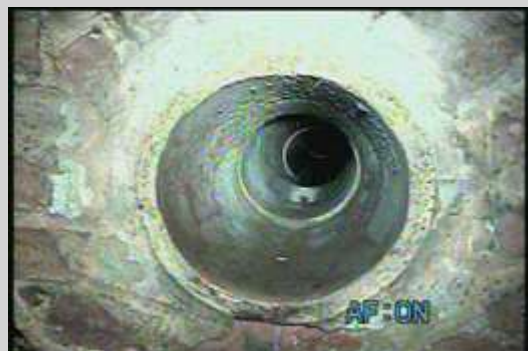
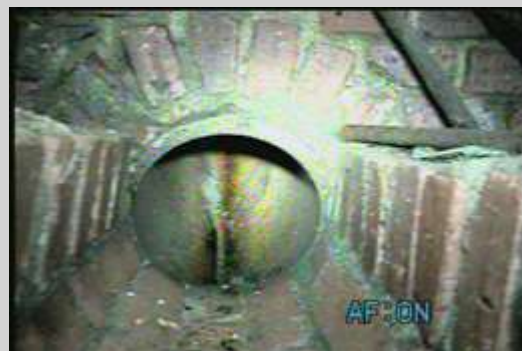
6 O'Clock Inflow

Pipe Material: **Clay** ☐ Pipe Lined

Infiltration: **None** Pipe Seal Cond: **Unknown**

Drop Condition: **Open**
